WARNING LETTER

Re: Stormwater Inspection – Grant Park Addition (Permit No. SDR10K637)

Project Name: Phillips Crossing Addition
 Inspection Date: June 6, 2022

Inspection Photo Log

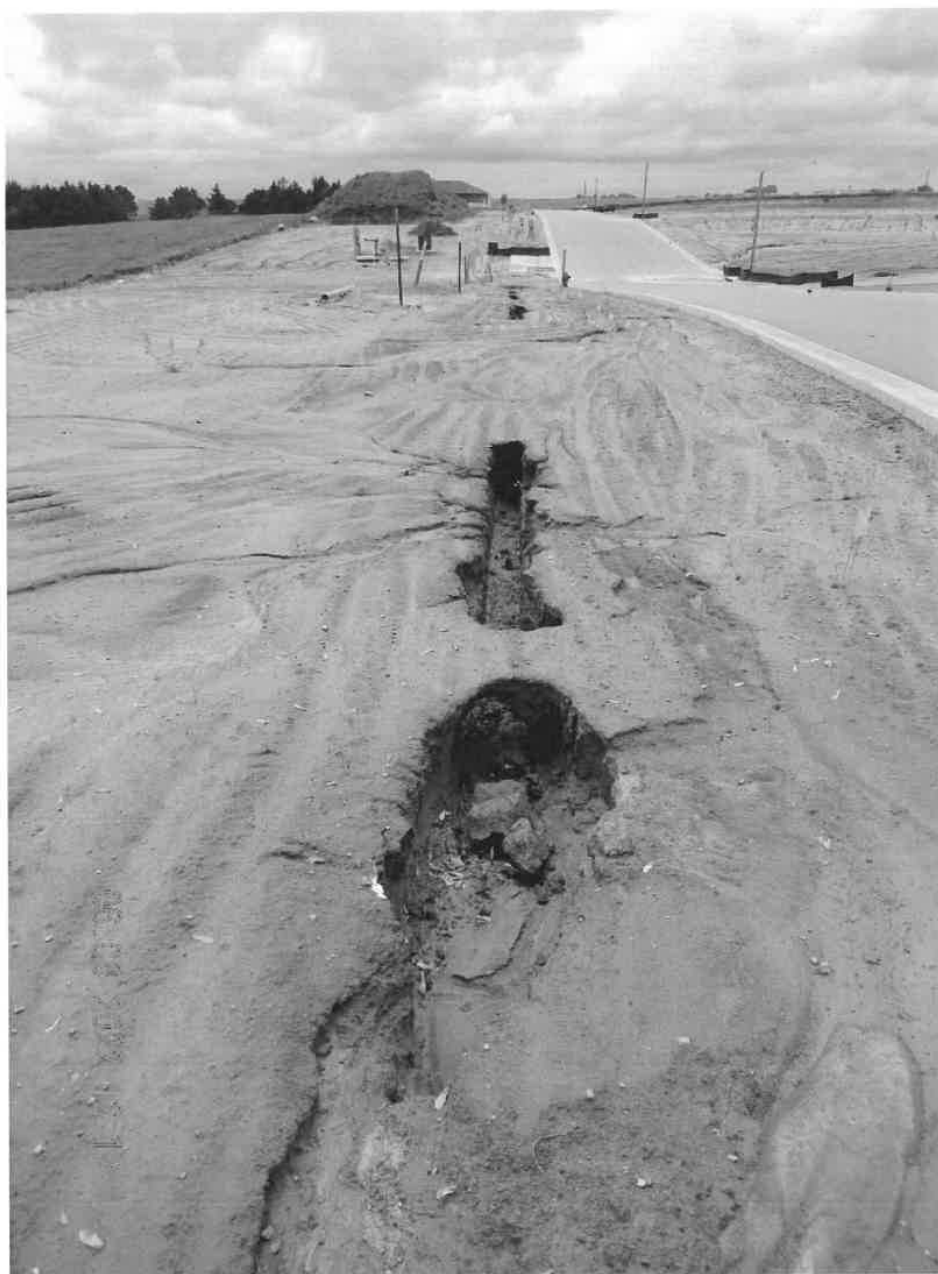
Picture 1

Picture	Facing	Photo Description
1		Unstabilized areas and utility trench causing erosion
2		Unstabilized areas and sediment discharged into street. No inlet protection installed on either side of street.
3		Erosion rills and sediment washed into street and in storm drain with no inlet protection.
4		Storm drain inlet with no sediment controls installed.
5		Silt fence installed upgradient of storm drain inlet but sediment from unstabilized areas flowed around it. Topsoil stockpile in background with vegetative cover.
6		Unstabilized areas showing erosion and where high concentrations of stormwater flow on west side of site in the gully washed out.
7		Storm drain inlet with no protection installed and exposed soil around it needs to be stabilized. Some seeded grass growth can be seen but not enough to prevent erosion.
8		Close up of storm drain inlet
9		Unstabilized areas and utility trench showing erosion. Top soil stockpile has vegetated cover.

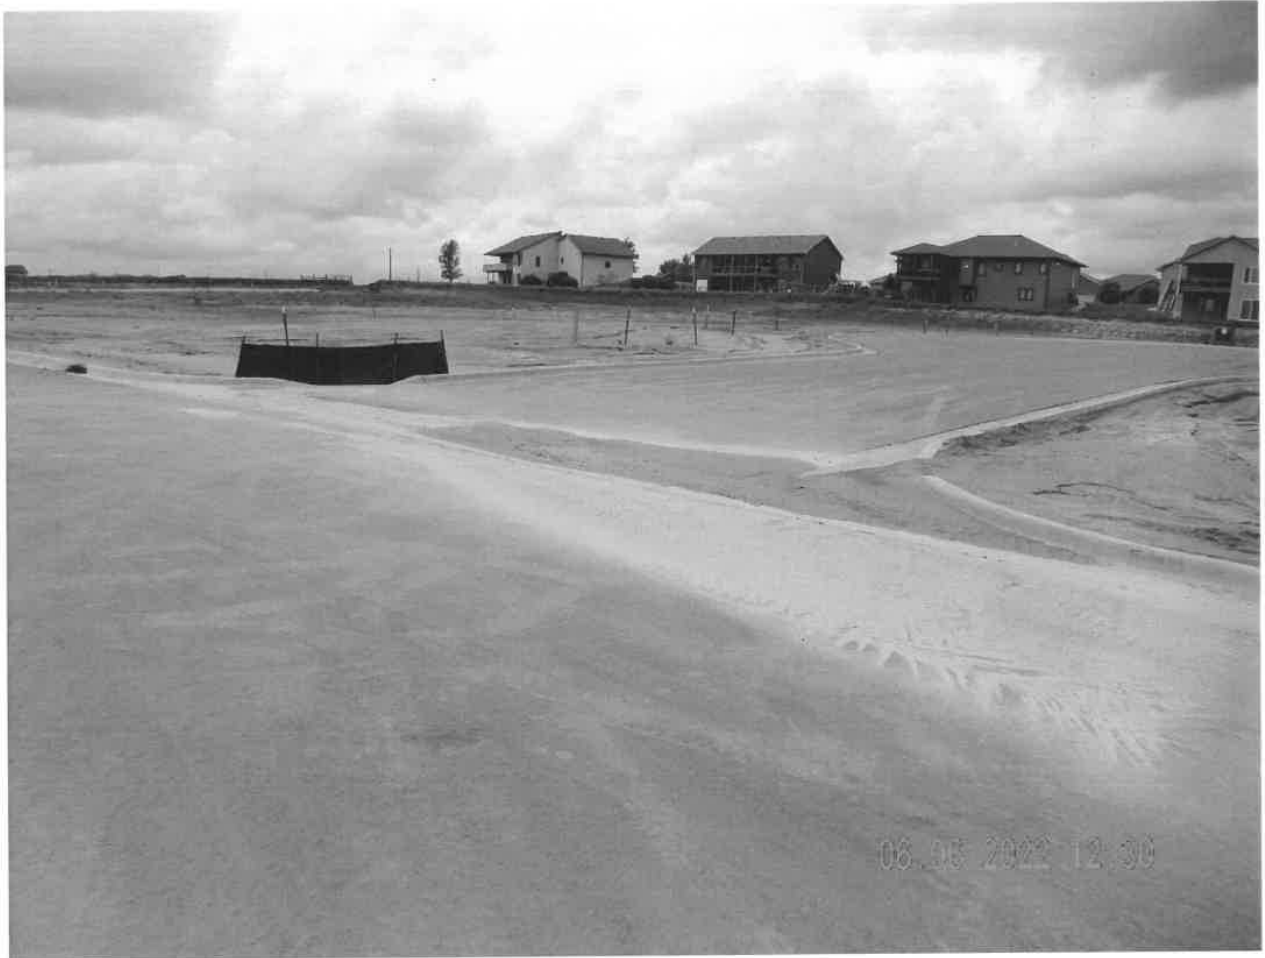
Picture 10

10		Sediment runoff into street needs removed. Exposed soils need stabilization to prevent further erosion.
11		Exposed soils need to be stabilized to prevent further erosion and sediment runoff. Silt fence may need maintenance as it looks to have sediment buildup along bottom from high flows. Sediment has washed over the curb; silt fence needs to be extended to capture off-site flows.
12		Some seeded growth but not sufficient to prevent erosion.
13		Rubble piles should be noted on SWPPP map or removed from site.
14		Material stockpiles should be moved further from street to prevent sediment runoff. Sediment and material in gutter needs to be removed.
15		Stockpile from bike bath construction owner stated was being actively used. Some seeded growth can be seen but not enough to prevent erosion. Sediment in gutter needs to be removed.
16		Stormwater outfall needs debris removed and sediment discharged offsite removed. Exposed soils need stabilization to prevent further erosion.

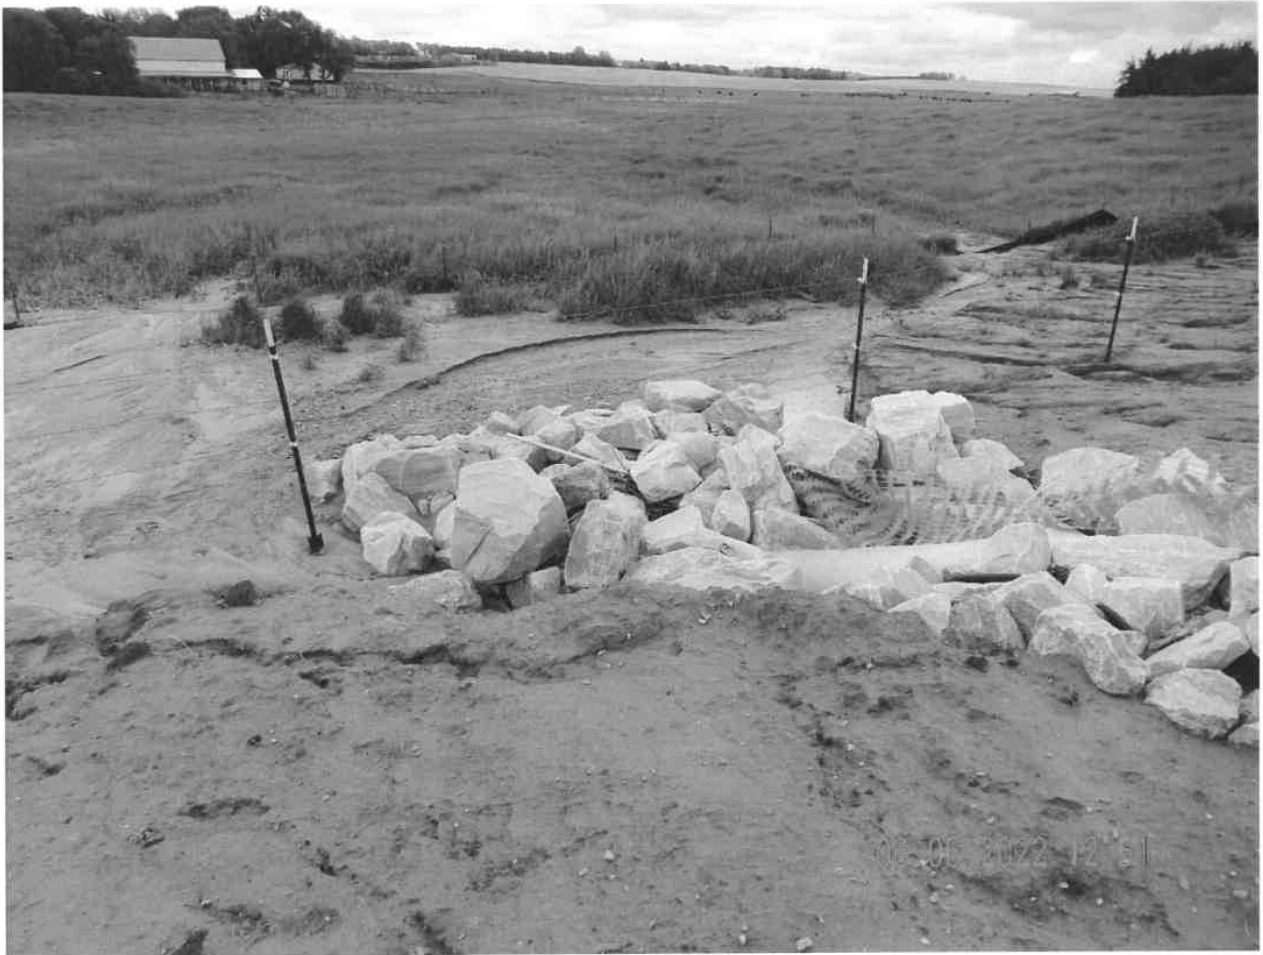
Picture 17

17		Stormwater outfall needs sediment cleaned up and sediment discharged into neighboring property needs removed. Snow fence debris should be cleaned up. Silt fence is completely covered with sediment and should be removed. Erosion controls should be installed on site property.
18		Erosion rills and gullies north side of stormwater outfall. Stabilize exposed soil to prevent further erosion.
19		Sediment discharged offsite into road ditch. Exposed soils need to be properly stabilized to prevent further erosion. Snow fence debris should be cleaned up.

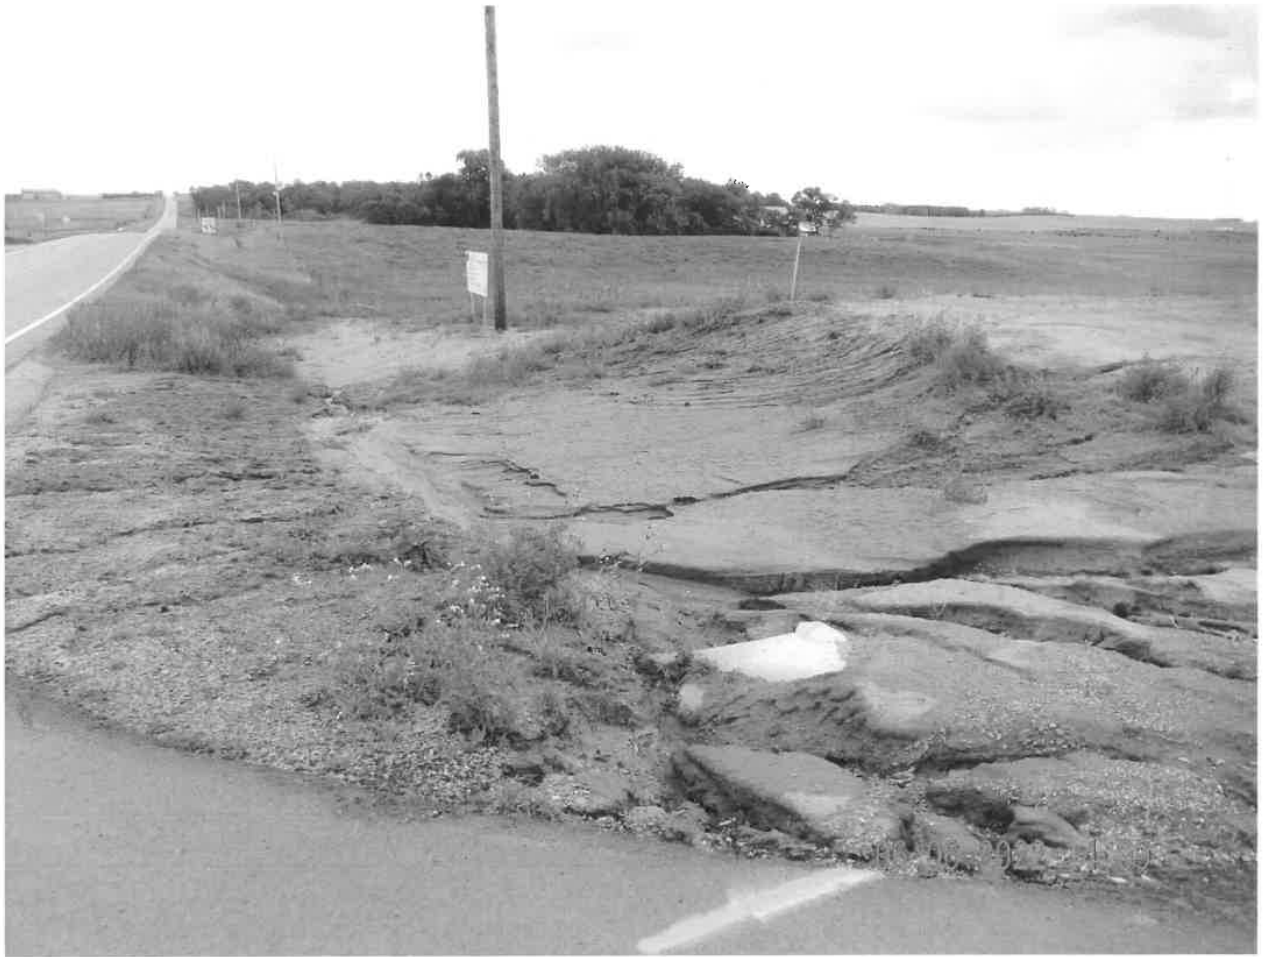
Picture 20

20	Sediment discharged offsite into road ditch on northeast end of project. Sediment needs to be cleaned up and exposed soils properly stabilized to prevent further erosion.
----	--
